# Home Inspection Report

**Report Number: 183**  
**For The Property Located On:**  
123 EC DOES IT Ave.  
Raleigh, North Carolina 27613

Date of Inspection: Thursday, October 15, 2015

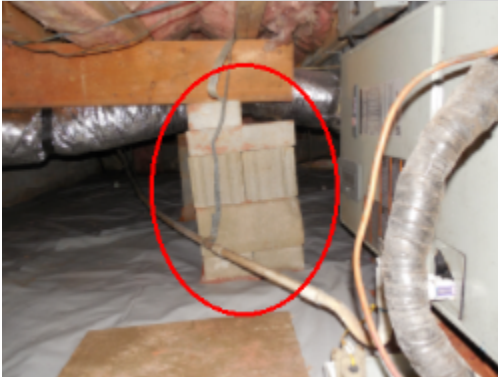
#### (A1 - 1.1 ) Main House

A pier was noted to be leaning and not properly bearing under girder located under the kitchen area near HVAC cabinet. (The floor in the kitchen above this area has a notable hump). A licensed general contractor should be consulted for further evaluation and repair. If the repair is beyond the scope of the Building code, a professional engineer should be consulted to outline the repair.

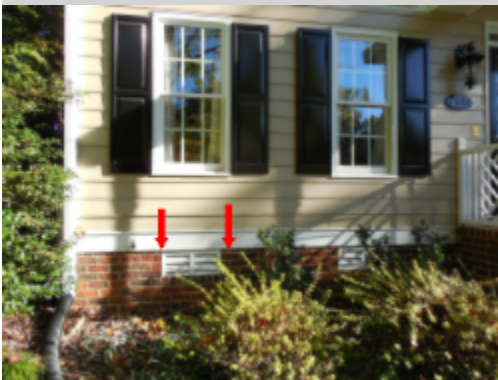
#### (A1 - 1.2 ) Main House

Closed & open cracks were noted in the foundation of the home.

Cracks in the foundation indicate a deficiency in the foundation, footing, or supporting soil that can change and worsen if it progresses over the life of the home. An engineer should be consulted to determine the significance /cause of the cracks and outline any necessary repairs.

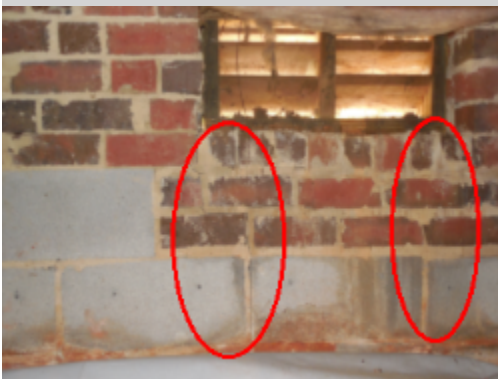
#### (A1 - 1.3 ) Main House

Additional photo of cracks noted at front left foundation vent area.

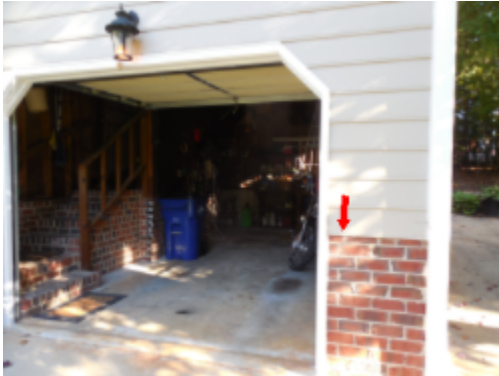
#### (A1 - 1.4 ) Main House

Additional photo of closed crack noted in brick veneer at right side of garage door.

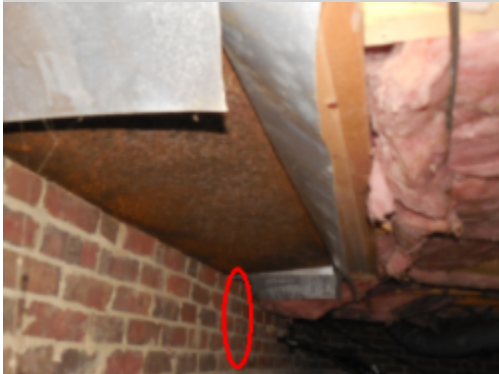
**(A1 - 1.5 ) Main House**

Additional crack noted in foundation under fireplace location.

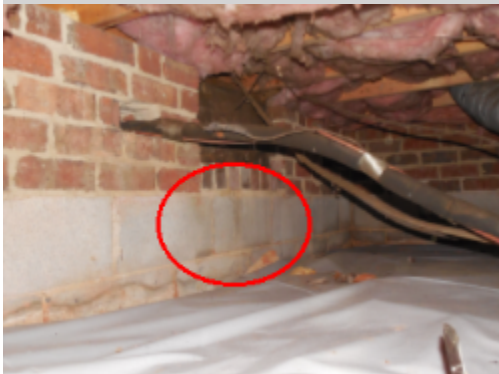
**(A1 - 1.6 ) Main House**

Evidence suggests water is entering the foundation area through the foundation vent located between the the AC condensers on the left side of home. Water infiltration can cause environmental concerns and decay. A licensed general contractor should be consulted for a complete evaluation and to make necessary repairs.

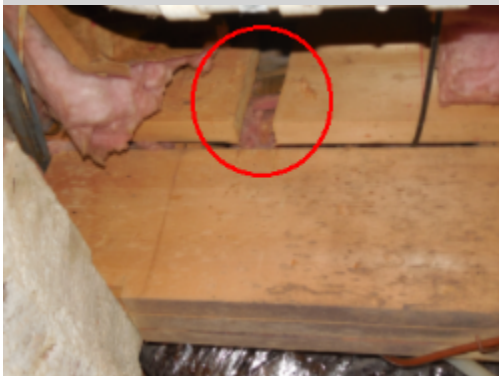
**(A3 - 1.1 ) All Accessible Areas**

The floor joist located under kitchen sink has been cut and does not have proper bearing to provide proper end support for the floor system. Proper bearing is required to ensure the stability of the framing and floor structure. A licensed contractor should be consulted for further evaluation and to make necessary repairs.

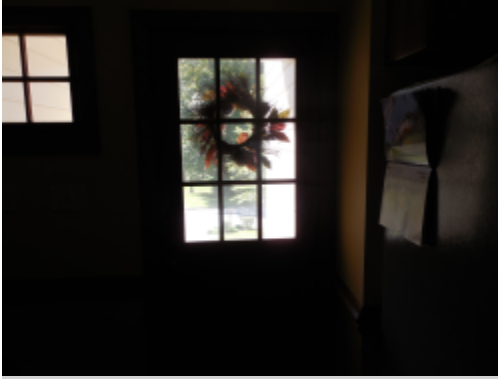
The kitchen & dinette doors have a cloudy or hazed appearance. The cloudy appearance indicates that the gas seal between the double glass panes has been jeopardized reducing the energy rating of the doors. The severity of the hazing varies with season and time of the day; therefore, all damaged seals may not have been visible at the time of the inspection. All doors should be evaluated as repairs are made. A licensed general contractor should be consulted to evaluate the extent of the concern and make necessary repairs.

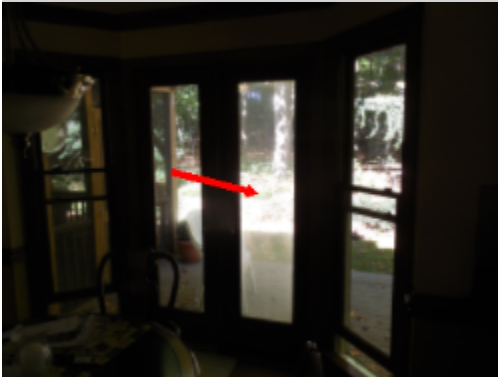
Additional photo of door with cloudy or hazed appearance in dinette area.

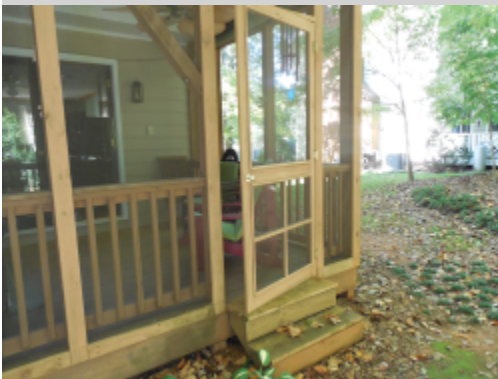
The screened porch door drags and is difficult to open or close. This condition could indicate improper installation or framing movement. The door needs repair/replacement to ensure that the door closes securely and operates properly. A general repair specialist or licensed general contractor should be consulted for evaluation and repair.

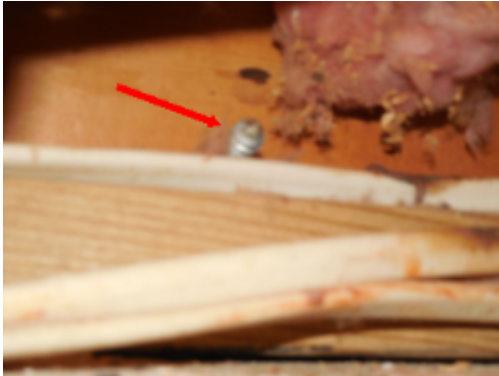
Lag bolts were noted to secure the deck to the home where bolts with washers and nuts are typically observed. Evidence suggests improvements have been made that are not original to the home. Determining whether the bolts comply to local permitting and/or building codes is beyond the scope of a home inspection. A licensed building contractor should be consulted for a complete evaluation.

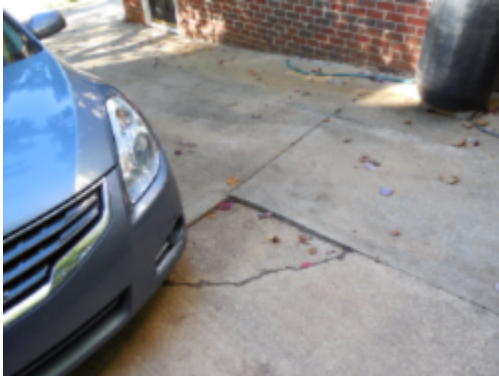
The driveway is cracked and displaced in a few locations. Sunken sections and cracks in a driveway creates a path for water penetration under the slab and a trip or fall hazard. A licensed general contractor should be consulted for further evaluation and repair.

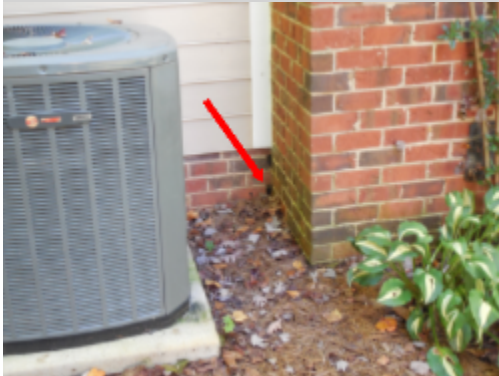
Cracks were noted at the base of the chimney as viewed from the left side yard, the crawl space and fireplace hearth area. The cracks indicate differential movement between the chimney and the house foundation. An engineer should be consulted to review the chimney and the foundation to determine the significance of the concern and to outline necessary repairs.

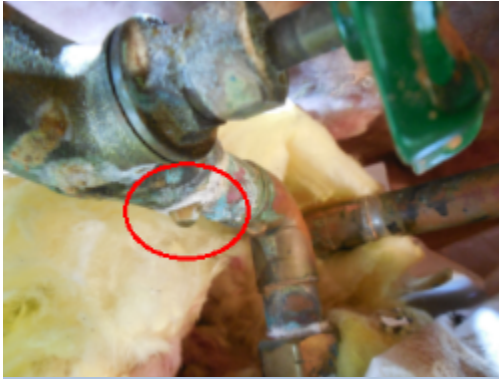
A shut off valve at top of water heater was noted to be leaking and needs to be repaired to prevent any additional water from entering the foundation area. Direct water infiltration can cause environmental and/or property damage. A licensed plumbing contractor should be consulted for a complete evaluation of the water heating system and to make necessary repairs.

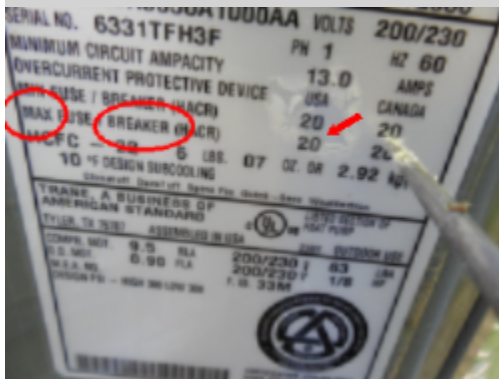
The conductors and the 50 amp breakers located on the left/bottom side of the main panel (AC's) are not compatible. The breaker and conductor must be matched to safely provide the required service and ensure that the appliance or components of the branch circuit are protected. This condition presents a safety hazard that could result in interrupted service, property damage, and serious personal injury. A licensed electrical contractor should be consulted for further evaluation and repair.

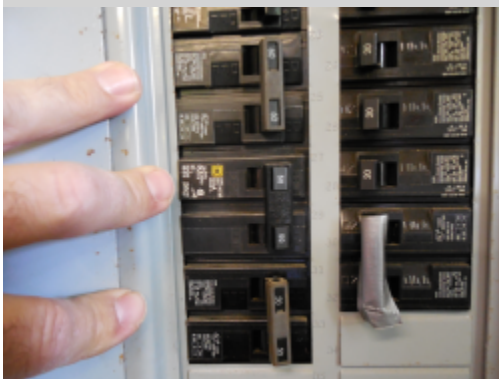
Additional photo showing incorrect amperage breakers for AC system (20 amp max).

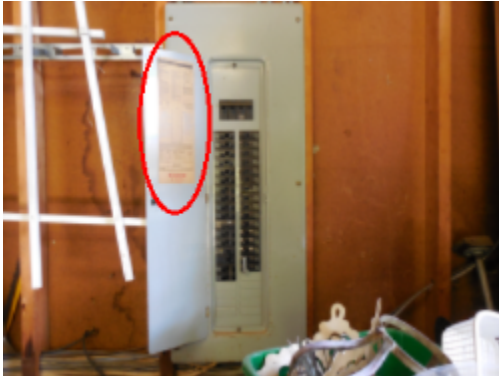
The electrical circuits in the main panel were not completely labeled and could not be verified to have a safe and effective way to quickly turn the power off in case of an emergency. A licensed electrical contractor should be consulted for a complete evaluation of the electrical system to label and identify the panel disconnect method and or make necessary repairs to ensure a safe and properly functioning system.

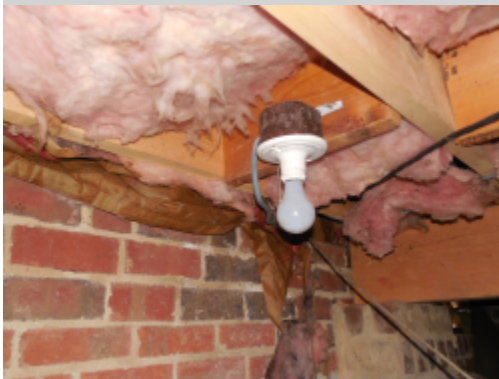
### **(E5 - 2.1 ) Crawl Space**

The light fixture located in the crawl space near the front porch area was not functional when tested. This could indicate a defective bulb or other more serious problem such as faulty wiring or a defective fixture, further evaluation and repair is needed. A licensed electrical contractor should be consulted for further evaluation and repair.

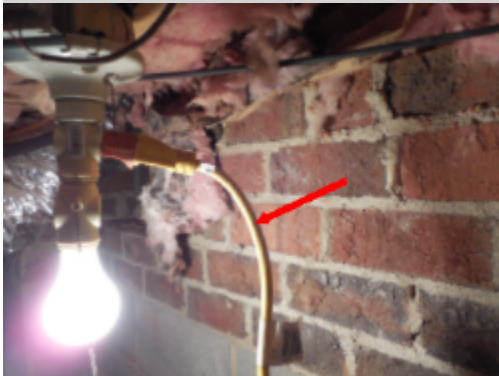
Extension cords have been used to hard wire crawl space ventilation fan. This indicates amateur electrical work and could result in increased shock and fire hazards. A licensed electrical contractor should be consulted to review the installations and make necessary repairs to ensure safe and proper operation and installation.

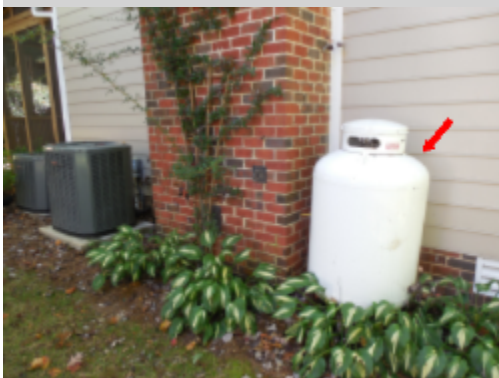
The above ground propane fuel storage tank is located at left side of home; storage tanks are either leased from the fuel supplier or owned by the homeowner. The client should request more information concerning the storage tank, service requirements and ownership.

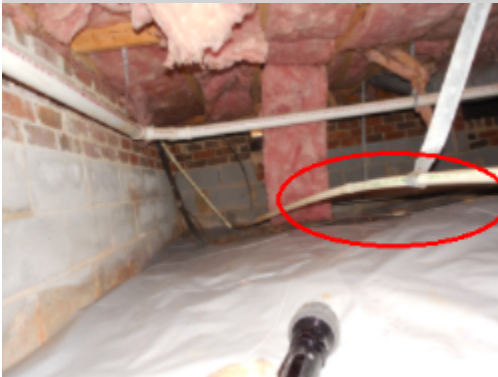
The condensate drain line is not properly installed with a downward pitch from the HVAC cabinet to the location where it exits the foundation wall. The line pitches upward in the middle section and could hold condensate water. Improper drainage of the condensate water can result in system and property damage. A HVAC contractor should be consulted for a complete evaluation and repair of the system to ensure reliable and proper operation of the HVAC system.

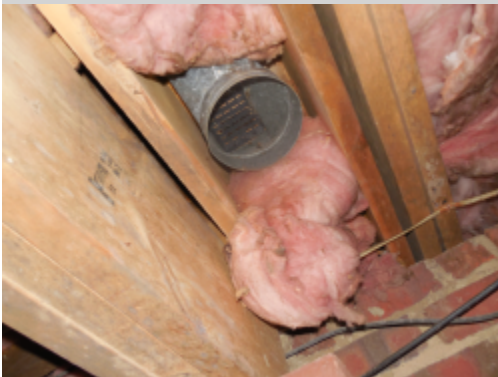
The duct that supplies heating and air to the dinette area is disconnected and needs to be repaired. A HVAC contractor should be consulted for a complete evaluation and repair of the duct system to ensure reliable and proper operation of the HVAC system.

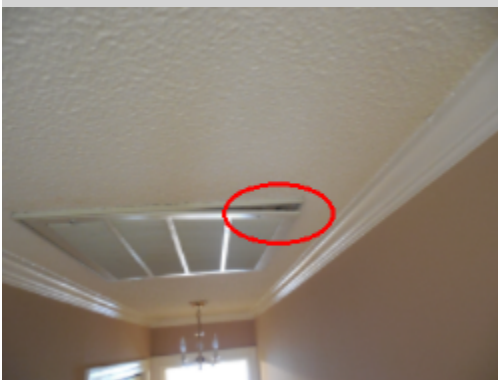
The grill on the HVAC return located in upstairs hall is damaged/loose and needs repair to prevent it from falling. A HVAC contractor should be consulted for a complete evaluation and repair of the duct system to ensure reliable and proper operation of the HVAC system.

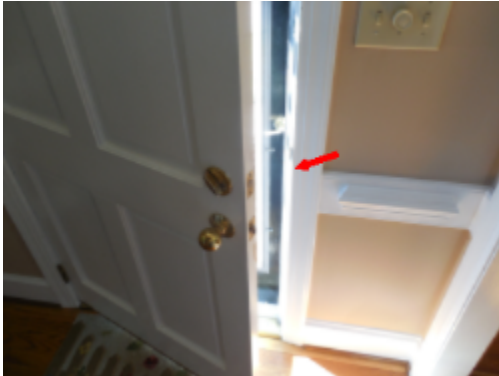
The door lock assembly is not aligned with the striker in the jamb area. The lock could not be engaged to secure the door. The door/lock needs repair/replacement to ensure that the door closes securely and operates properly. A general repair specialist or licensed general contractor should be consulted for evaluation and repair.

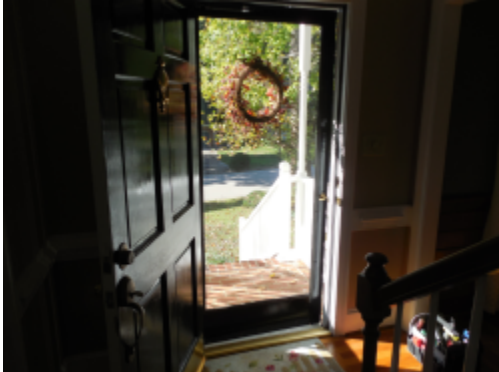
The front storm door drags and is difficult to open or close. This condition could indicate improper installation or framing movement. The door needs repair/replacement to ensure that the door closes securely and operates properly. A general repair specialist or licensed general contractor should be consulted for evaluation and repair.

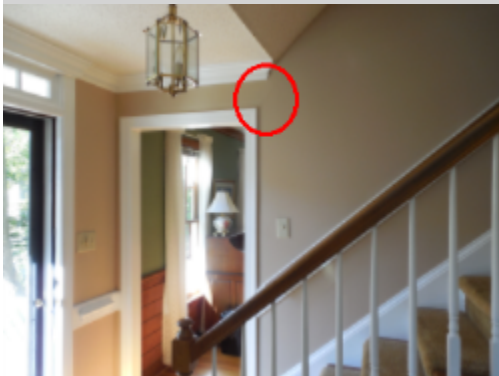
The wall in the foyer is cracked at entrance to living room. No related concerns were noted in the throughout the other inspection areas. If additional concerns or questions are present, invasive inspection and repair will be needed.

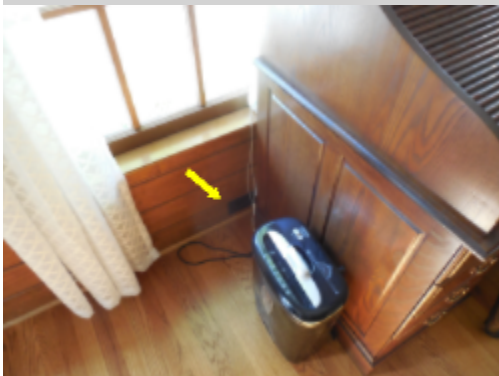
The receptacle located at the front living room wall is loose. Loose receptacles could result in electrical shock hazard or property damage. A licensed electrical contractor should be consulted for a complete evaluation to determine the significance of this concern and make necessary repairs to correct defects and prevent safety hazards.

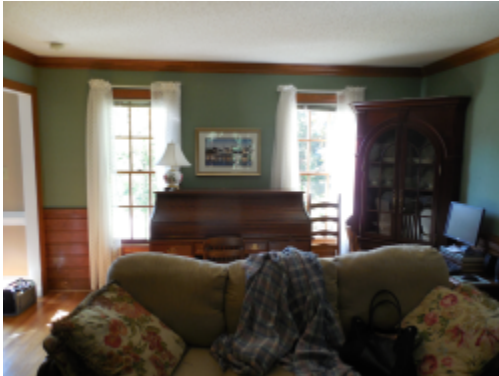
The windows in the living room needs repair to ensure proper operation. The window could not be opened. A licensed general contractor should be consulted for evaluation and repair.

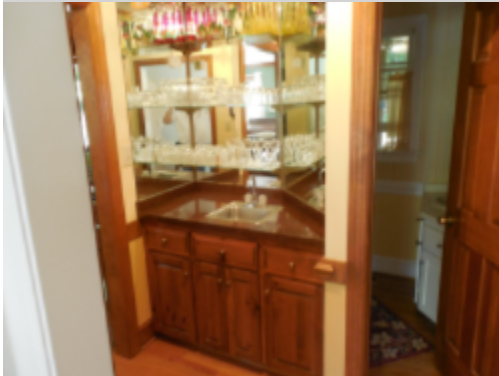
The wet bar sink drain was noted to be slow. A slow drain could indicate a clogged line or an underlying problem with the drain/waste/vent system. A licensed plumbing contractor should be consulted for evaluation and repair to ensure proper service.

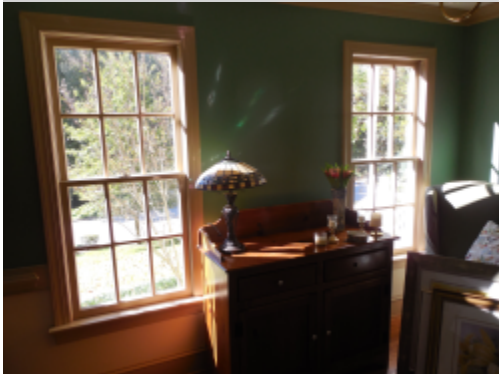
The windows in the dining room needs repair to ensure proper operation. The windows could not be opened. A licensed general contractor should be consulted for evaluation and repair.

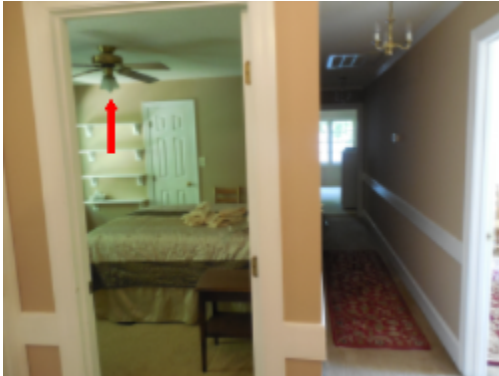
The light fixture located on the #1 bedroom ceiling fan was not functional when tested. This could indicate a defective bulb or other more serious problem such as faulty wiring or a defective fixture, further evaluation and repair is needed. A licensed electrical contractor should be consulted for further evaluation and repair.

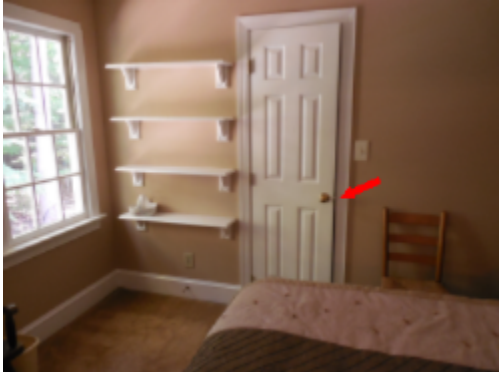
The door lock assembly is not aligned with the striker in the jamb area at the #1 bedroom closet door. The lock could not be engaged to secure the door. The door/lock needs repair/replacement to ensure that the door closes securely and operates properly. A general repair specialist or licensed general contractor should be consulted for evaluation and repair.

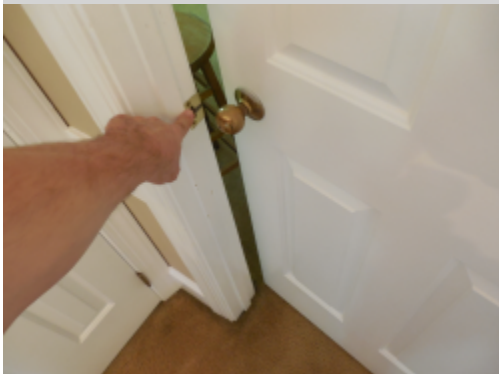
The door lock assembly is not aligned with the striker in the jamb area at the #1 bedroom door. The lock could not be engaged to secure the door. The door/lock needs repair/replacement to ensure that the door closes securely and operates properly. A general repair specialist or licensed general contractor should be consulted for evaluation and repair.

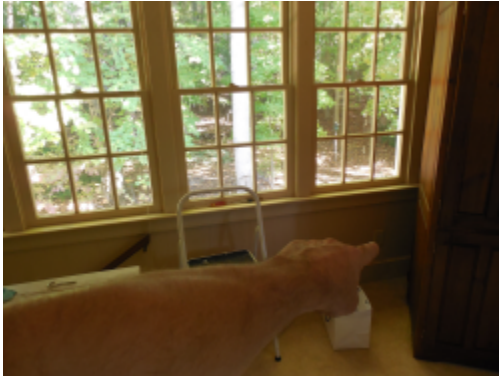
The receptacle located at the rear wall in the bonus room is loose. Loose receptacles could result in electrical shock hazard or property damage. A licensed electrical contractor should be consulted for a complete evaluation to determine the significance of this concern and make necessary repairs to correct defects and prevent safety hazards.

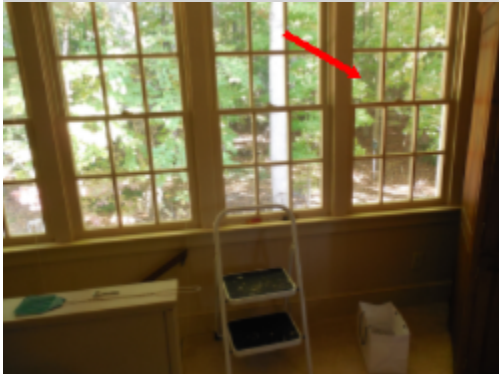
The window in the bonus room needs repair to ensure proper operation. The window could not be opened. A licensed general contractor should be consulted for evaluation and repair.

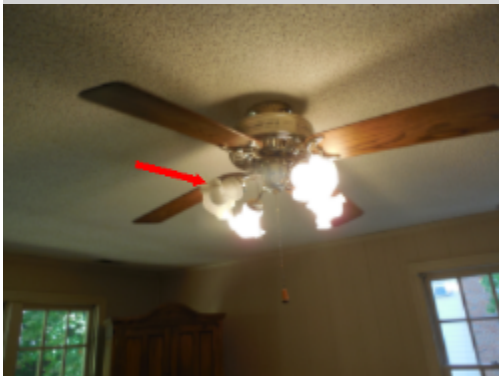
The light fixture located on the bonus room ceiling fan was not functional when tested. This could indicate a defective bulb or other more serious problem such as faulty wiring or a defective fixture, further evaluation and repair is needed. A licensed electrical contractor should be consulted for further evaluation and repair.

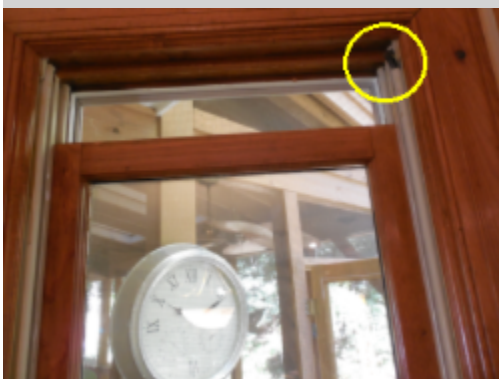
The sash spring was noted to be disconnected on the kitchen window near back door during the inspection. The sash springs assist in lifting and holding the window in place when it is opened. When the springs are disconnected or broken the window will not remain in the open position and can drop suddenly resulting in personal injury. Repair is needed to ensure proper function of the window. A general repair specialist or licensed general contractor should be consulted for evaluation and repair.

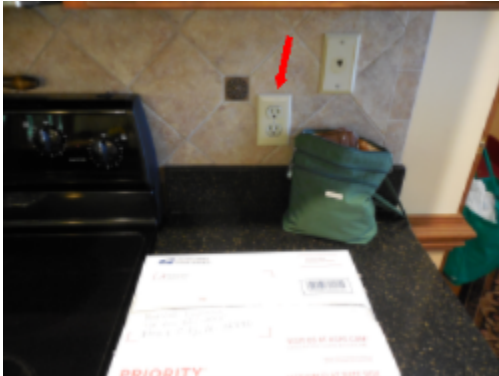
The receptacle above the range is loose. Loose receptacles could result in electrical shock hazard or property damage. A licensed electrical contractor should be consulted for a complete evaluation to determine the significance of this concern and make necessary repairs to correct defects and prevent safety hazards.

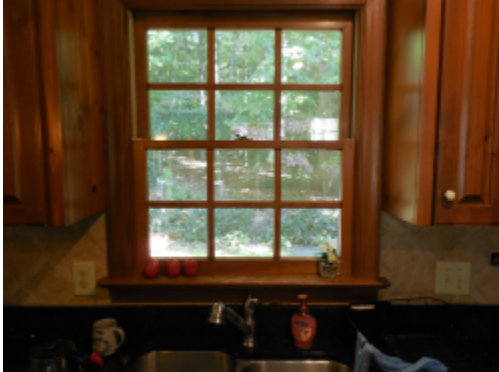
The window in the kitchen needs repair to ensure proper operation. The window could not be opened. A licensed general contractor should be consulted for evaluation and repair.

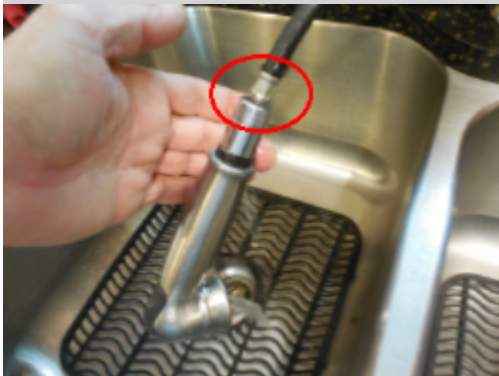
The faucet pull out spray handle was leaking and dripping water into the sink base cabinet when in use. Repair or replacement is needed. A licensed plumbing contractor should be consulted for evaluation and repair to ensure proper service.

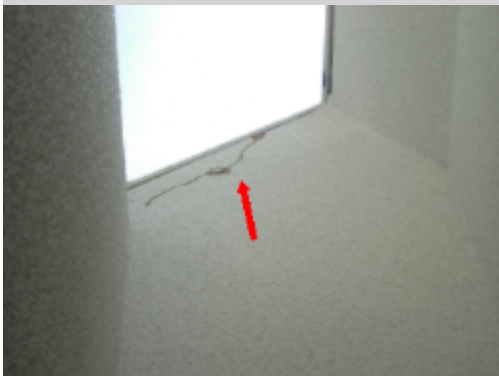
Cracks and damage were noted in the master bathroom skylight area. Skylights are susceptible to leaking and causing damage to the home. A licensed general contractor should be consulted for a complete evaluation to determine the significance of this concern and make necessary repairs.

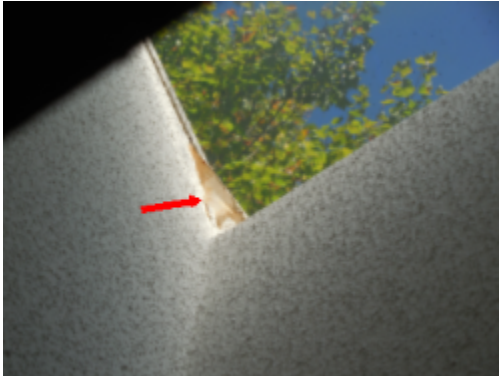
Additional photo of damage noted at master bathroom skylight area.

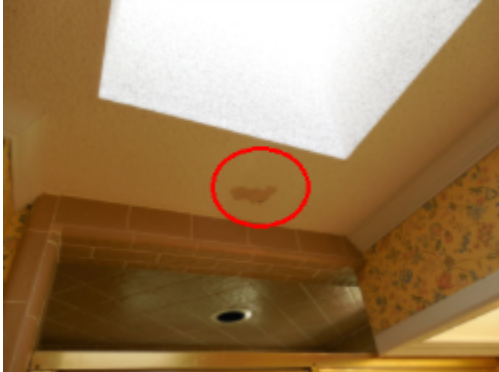
The textured ceiling covering was noted to be loose in several areas on the ceiling. The loose texture indicates improper texture installation or elevated moisture levels. A general repair specialist should be consulted to determine why the texture is loose and repair as needed to prevent further damage.

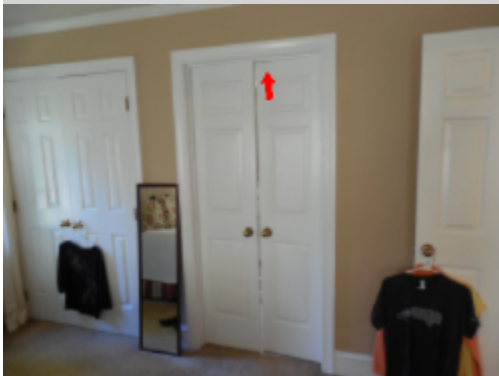
The door lock assembly is not aligned with the striker in the jamb area. The lock could not be engaged to secure the door. The door/lock needs repair/replacement to ensure that the door closes securely and operates properly. A general repair specialist or licensed general contractor should be consulted for evaluation and repair.

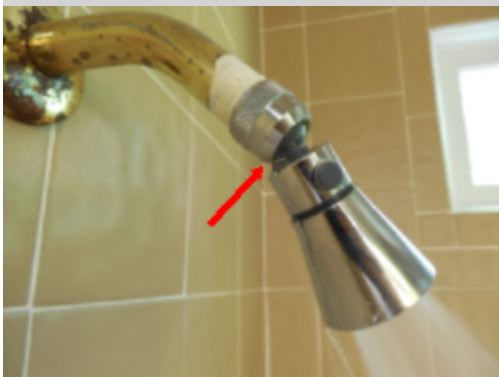
The shower head in the master bathroom shower leaks at the swivel and needs repair. A general repair specialist or a plumbing contractor should be consulted.

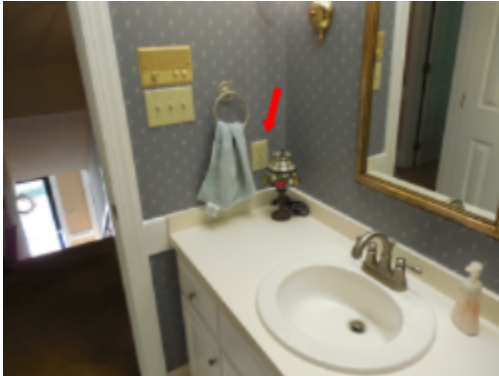
The receptacle located in the #1 bathroom is loose. Loose receptacles could result in electrical shock hazard or property damage. A licensed electrical contractor should be consulted for a complete evaluation to determine the significance of this concern and make necessary repairs to correct defects and prevent safety hazards.

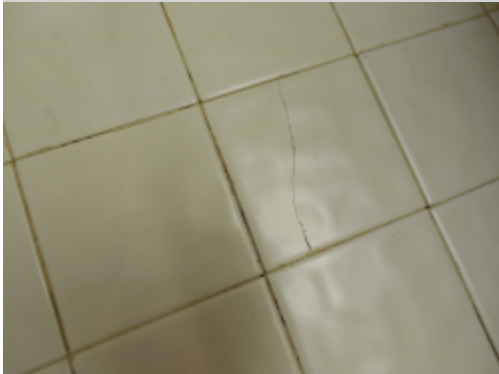
The tile system for the bathroom floor needs evaluation and repair related to loose and cracked tiles. A tile installation/repair company should be consulted to evaluate the tile system to determine the significance of the concern and make necessary repairs.

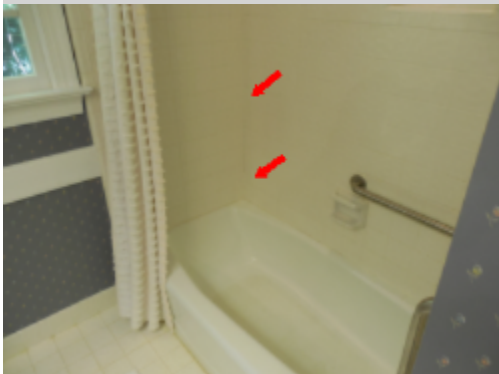
The tile system for the shower walls needs evaluation and repair related to low/ soft grout. The purpose of the grout is to fill the space between the tiles and protect the bond between the tile and the mortar base. A tile installation/repair company should be consulted to evaluate the tile system to determine the significance of the concern and make necessary repairs.

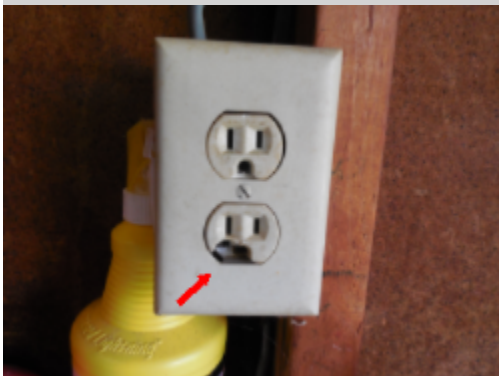
The receptacles located near garage pedestrian door and opposite wall have a cracked face. A cracked receptacle could result in increased shock and fire hazards. A licensed electrical contractor should be consulted to make necessary repairs to ensure safe and proper operation and installation.

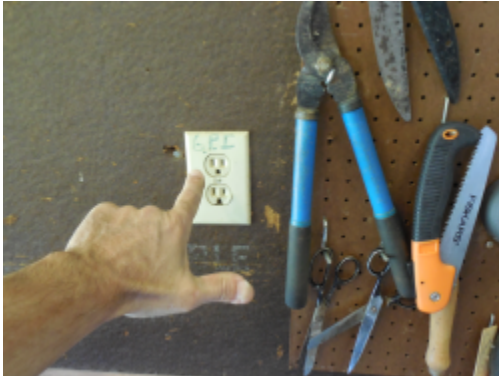
Additional photo of a loose receptacle with a cracked face in garage.

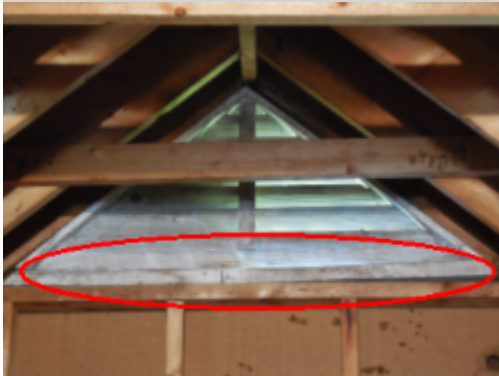
The screening on the gable vent located on the left side of home did not cover entire vent area which could allow animals to enter the attic area. A general repair specialist should be consulted for repair.

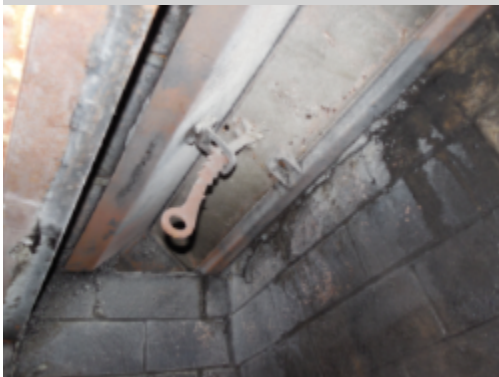
The fireplace does not have a damper lock. The damper lock ensures that the damper never closes completely to prevent hazardous operation of the gas log unit. This is a hazardous condition that needs correction. A licensed general contractor should be consulted for a complete evaluation and repair.

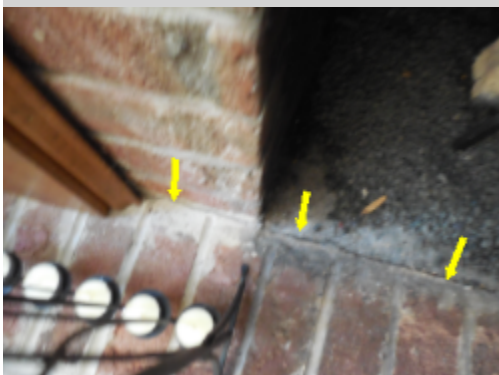
A closed crack was noted between the hearth and firebox at the left side of the fireplace opening. The hearth & fireplace needs further investigation. A licensed general contractor should be consulted for a complete evaluation and repair.

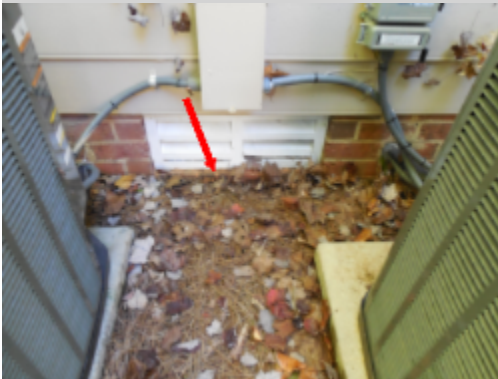
The grading near the air conditioning condensers is too high and is covering the lower side of the foundation vent. Incorrect clearance can result in water penetration, drainage, and conditions conducive of insects and decay. A licensed general contractor should be consulted to evaluate and correct the grading as needed for proper clearance and drainage.

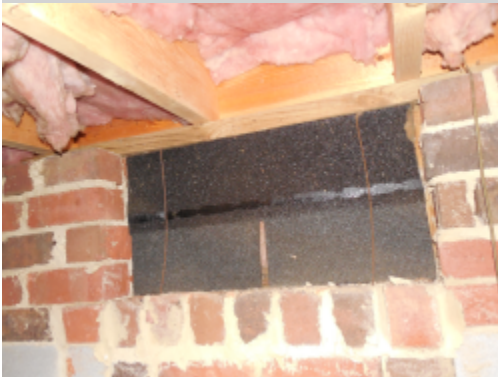
The foundation vents for the home have been sealed in an attempt to create a closed crawl space system. The configuration does not meet industry standards and needs a complete review. An engineer or licensed general contractor who specializes in closed crawl space systems should be consulted for a complete evaluation of the system and outline repair /maintenance requirements.

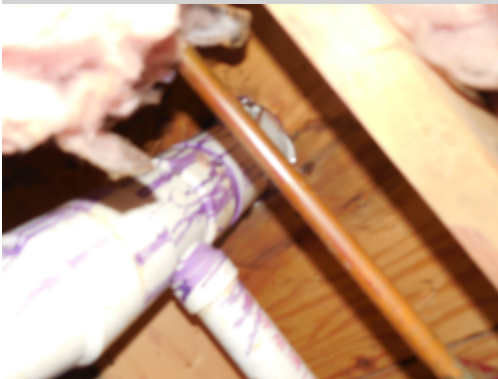
Several sections of insulation in the crawl space are falling or missing. Improper insulation installation could result in condensation, overheating of the building components, and inadequate conditioning of the living areas. A licensed general contractor should be consulted for repair/ replacement.

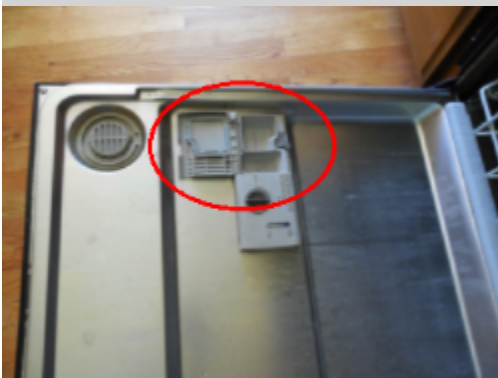
The soap dispenser door did not function as intended during normal wash cycle. An appliance repair person should be consulted for further evaluation and repair to ensure proper operation of the appliance.

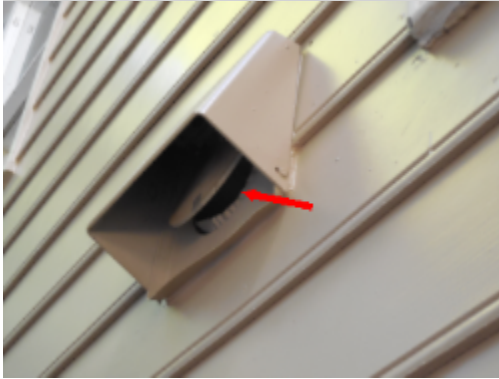
The baffle for the dryer is does not shut all the way when not in use. The baffle should close to prevent air, insect and animals from entering the duct system. A licensed general contractor or general repair specialist should be consulted for further evaluation and to make necessary repairs.
